**Standard Home Inspection**

Doc #: 121031112 Inspector: Charles Cravens

Date: 10/31/2012

Dwelling Address: Any Street  
Tulsa Oklahoma

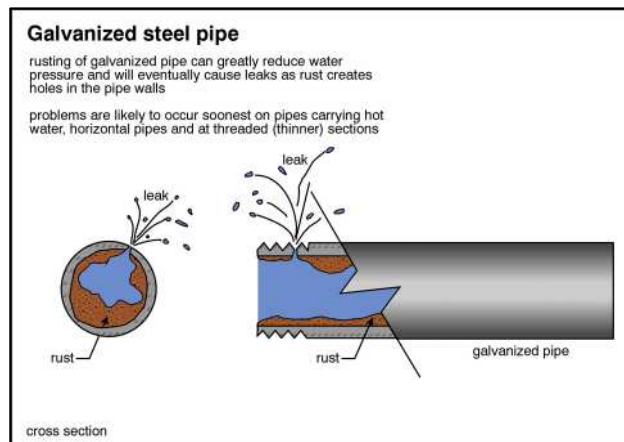
2110. Water Supply Lines

**Comments** . \*; Galvanized. No discrepancies were noted with the visible portions of the plumbing connections at the time of this inspection. Water supply lines installed from the meter to the house and under the slab floor are not a normal part of this inspection. The buyer may want to have a water line leak test performed by a qualified leak detection service. The potable water pipes within this residence are galvanized, and assumed to be original. They appear to be in acceptable condition. However, they may produce rusty looking water from time to time and, because the water volume in such pipes will gradually be reduced by a build-up of minerals within them, we do not endorse them. Galvanized water lines rust from the inside out and can become restricted over time. When low water flow is noted at plumbing fixtures, some restrictions may have occurred. We suggest further review by a qualified licensed plumbing contractor for repairs/replacement as needed to ensure proper water flow
