## SUMMARY REPORT

**Cravens Home Inspection Service**  
**PO Box 925**  
**Bixby, OK 74008**  
**Ph#: (918) 369-6947**

Doc #: 121031112  
Dwelling Address: Any Street  
Any City Oklahoma

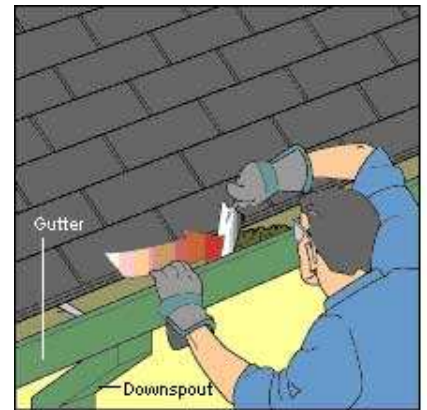
Fig. 1 , Scooping Out Gutter

The gutters contain leaves and debris and need to be cleaned and serviced to drain properly.

- Gutters are a key component in the controlled drainage of run-off water away from the home's exterior elements. Water backing up in the gutter may add sufficient weight to the gutter to cause its detachment from the structure and deterioration of the fascia, soffit or roof edge. Debris in gutters will also contribute to Ice Damming in the winter. Gutters that do not perform as intended may result in saturation of soils near the foundation, which in turn can result in basement moisture or leakage issues.
- Clean the debris from the gutters and assure that the water freely flows and drains from the gutter and bring to normal working order.

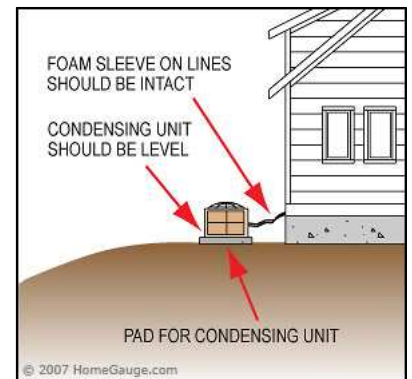
The refrigerant suction line insulation is missing / damaged.

- Insulation is required on the larger of the two coolant lines, to minimize heat gain to the coolant as it is transported through the line. The insulation around the return line (the larger line) to the air conditioner compressor helps improve efficiency of the unit. Often it will be worn off by gardening equipment, animals, etc., or may not have been secured when installed. The insulation cover should be complete along the full length of the coolant line, with no missing, damaged, or deteriorated sections. A section of un-insulated refrigerant line will cause a heat gain to the refrigerant. Heat gain of the system refrigerant during its transport from the inside unit (evaporator) to the outside unit (condenser) will reduce the system efficiency, waste energy, and increase operating cost.
- Install insulation on the refrigerant suction line and bring to normal.
