**C C** **CRAVENS** **INSPECTIONS** **HOME INSPECTION SERVICE**

## Dryer Vent Safety

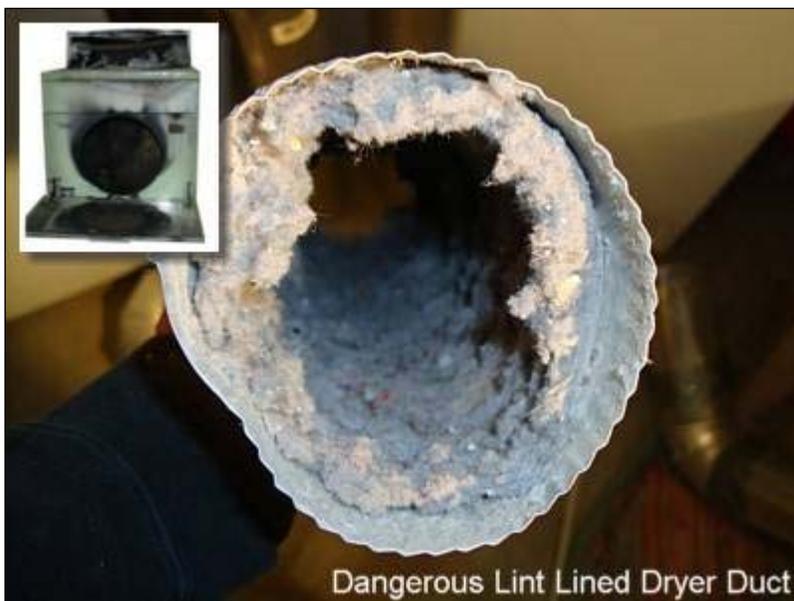
Exhaust ducts shall be constructed of minimum 0.016-inch-thick (0.4 mm) rigid metal ducts, having smooth interior surfaces with joints running in the direction of air flow. Exhaust ducts shall not be connected with sheet-metal screws or fastening means which extend into the duct.

This means that the flexible, ribbed vents used in the past should no longer be used. They should be noted as a potential fire hazard if observed during an inspection.
