Zinsco Electric Panels

May Leave Homes and Homeowners at Risk

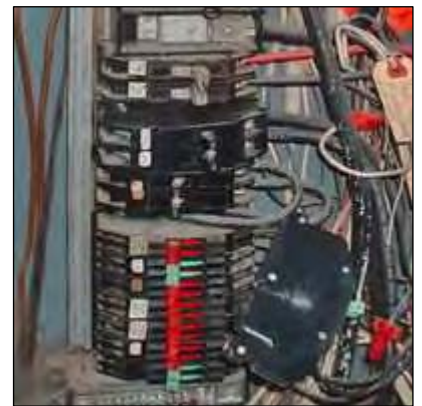
Most Zinsco panels are obsolete today. However, at one time, they were extremely popular and installed in many regions throughout North America. As time has passed, electricians and home inspectors have discovered that certain Zinsco panels often can fail to operate properly and may leave homes and homeowners at risk to both fire and electrical shock. These panels can work fine for years, but as homes have increased energy demands, these panels may overheat and portions of it melt.

In this situation, if a breaker melts to the bus bar of the panel and can no longer adequately trip in case of an over-current or short circuit, an extreme amount of power from the outside electrical supply surges into a home's panel and circuits. Once that happens, it cannot be stopped or shut off manually. Electricity will burn until it runs out of fuel or the wires melt. The panel could overheat and catch fire, causing serious harm to a home and its occupants.

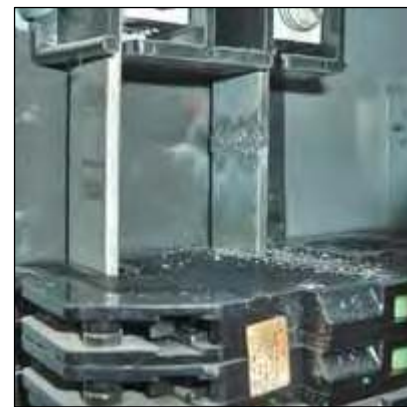
Problems with certain Zinsco panels cannot be seen by the naked eye. Even after the cover of Zinsco panels has been removed, everything can seem to be in fine working order. Upon exploring its components, electricians find that breakers cannot be removed from the bus bar. They've welded together, which indicates that the breakers have melted. In that condition, a breaker would be unable to trip and may be allowing an unsafe amount of electricity into the home! This could lead to a potential fire.

Please, do not attempt to remove breakers from your own panel to see if they've melted. Only licensed electricians should. Zinsco panels can be electrical shock risks; they can appear to be shut off but are still conducting electricity!

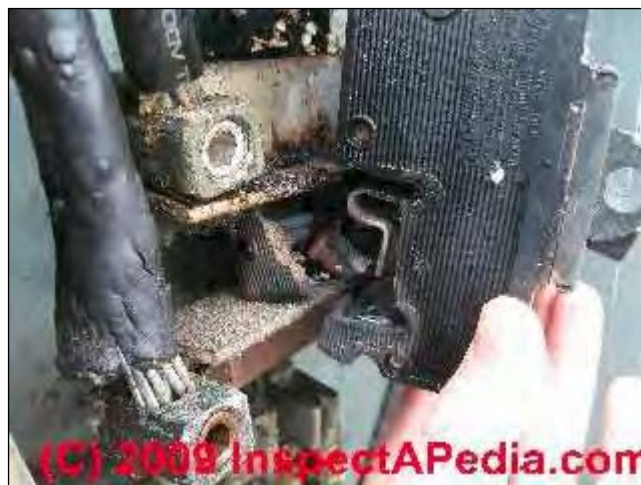
Limited test results reported by [J. Aronstein](#) indicate that the central Zinsco electrical panel and circuit breaker failure problem appears to be burn-ups at the clip-to-bus connection such as shown in our photo. The few circuit breakers tested by Dr. Aronstein were reported to trip within normal over-current limits. However a circuit breaker whose bus connection burns can lead to overheating damage to the circuit breaker itself, rendering it non-functional.

Photo of a burned and failed Zinsco main circuit breaker, courtesy of J. P. [Simmons](#) - Mr. Electric. Simmons adds: "In this case the failure damaged the main wire to a mobile home also (you can see the melted wire to the left of the main). This is a good example of why I do not like to see anyone remove these breakers. You can not tell how bad they are damaged by looking at them.

Where Zinsco and Zinsco-Sylvania electrical panels are discovered in buildings they should be replaced to reduce some very real fire and shock hazards. Building owners or electricians encountering problems with this equipment are asked to contact us to add that information to our electrical failure data base in an effort to develop accurate safety information which is then shared with appropriate federal and state agencies. Thanks to Mr. James Simmons, a licensed electrician with extensive field experience and the contributor of most of the photos and case reports at this web page.
